**REPORT NUMBER: SPNCAP-CAL-17-010**

**NEW CAR ASSESSMENT PROGRAM (NCAP)  
SIDE IMPACT POLE TEST**

**Fuji Heavy Industries LTD.  
2017 Subaru Impreza  
Four Door Sedan**

**FINAL REPORT**

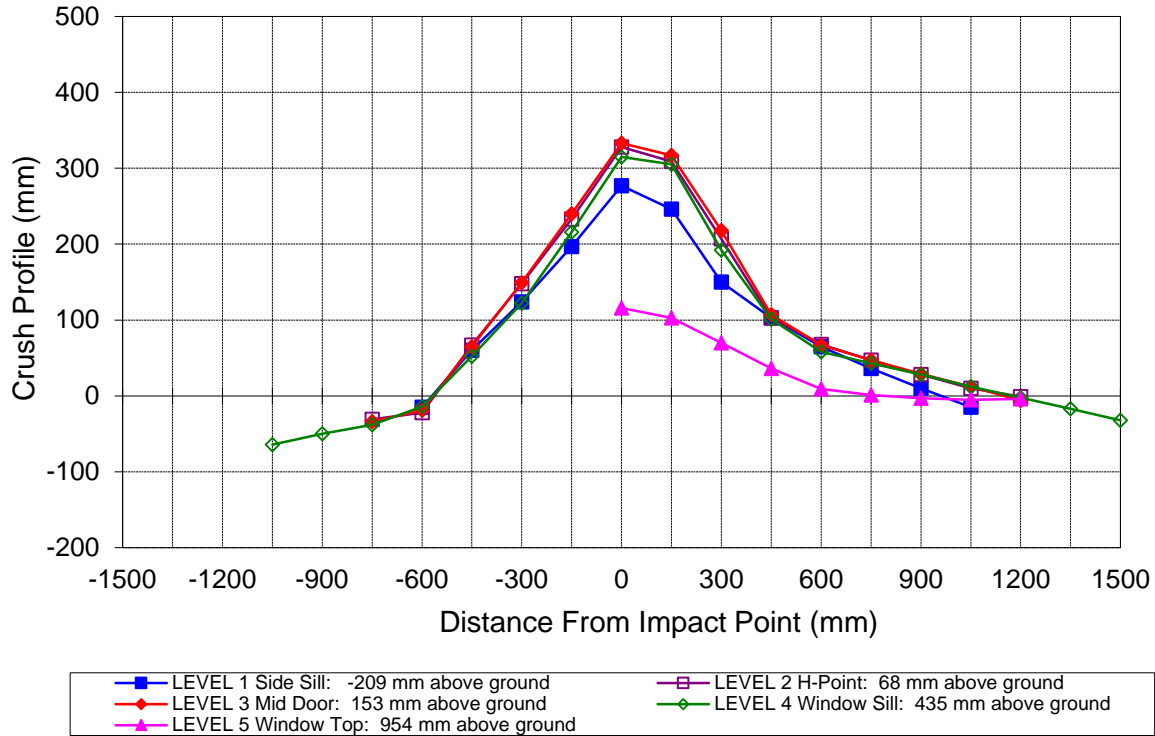
**Vehicle Exterior Crush Measurements - Visual Representation**

**NOTE:** Pre-test measurements are taken when the vehicle is in the "As Tested" weight condition. Vehicle measurements forward of the vertical impact reference line are negative. The crush profile grid is established prior to the test based on an estimated impact point. The final distance from impact is determined after the final dummy positioning and the pole is aligned with the center of gravity of the dummy's head.

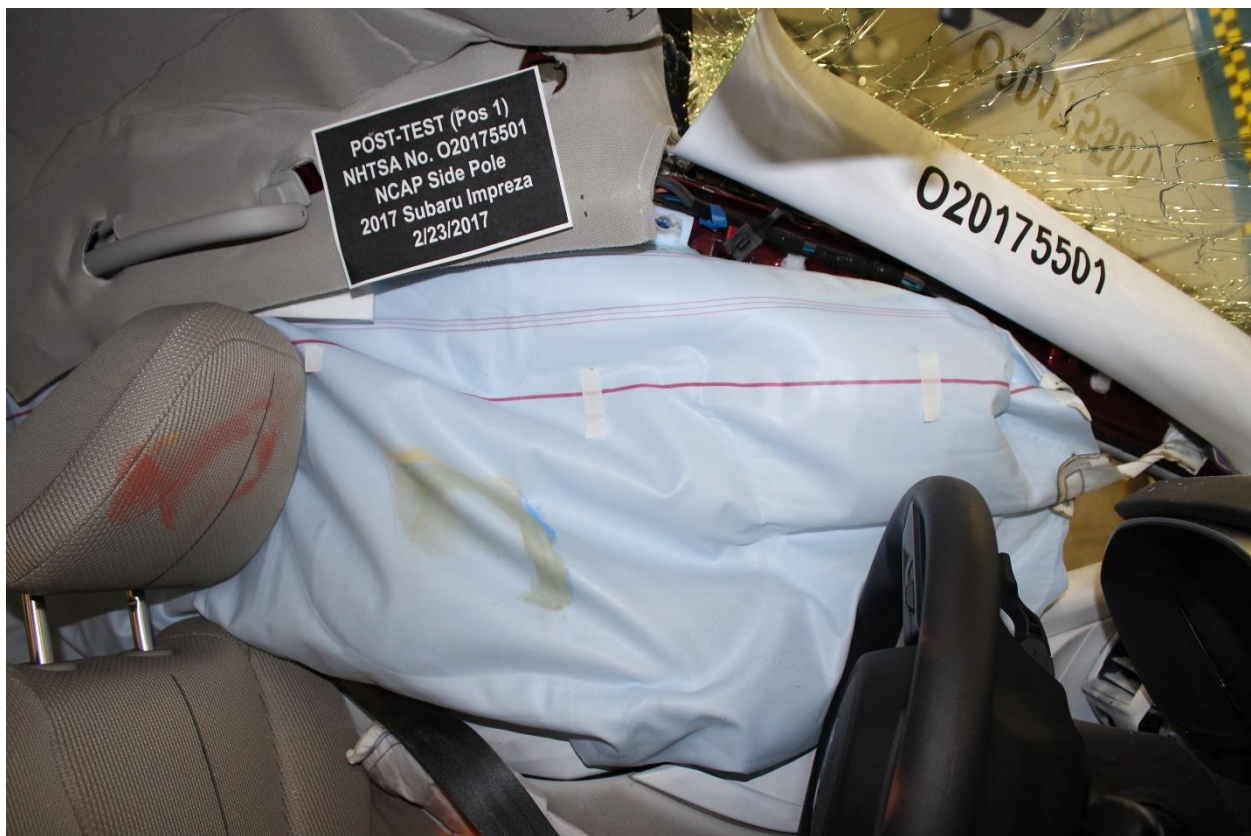
**Figure A-45: Post-Test Inner Door Panel View Showing Dummy Contact Location**

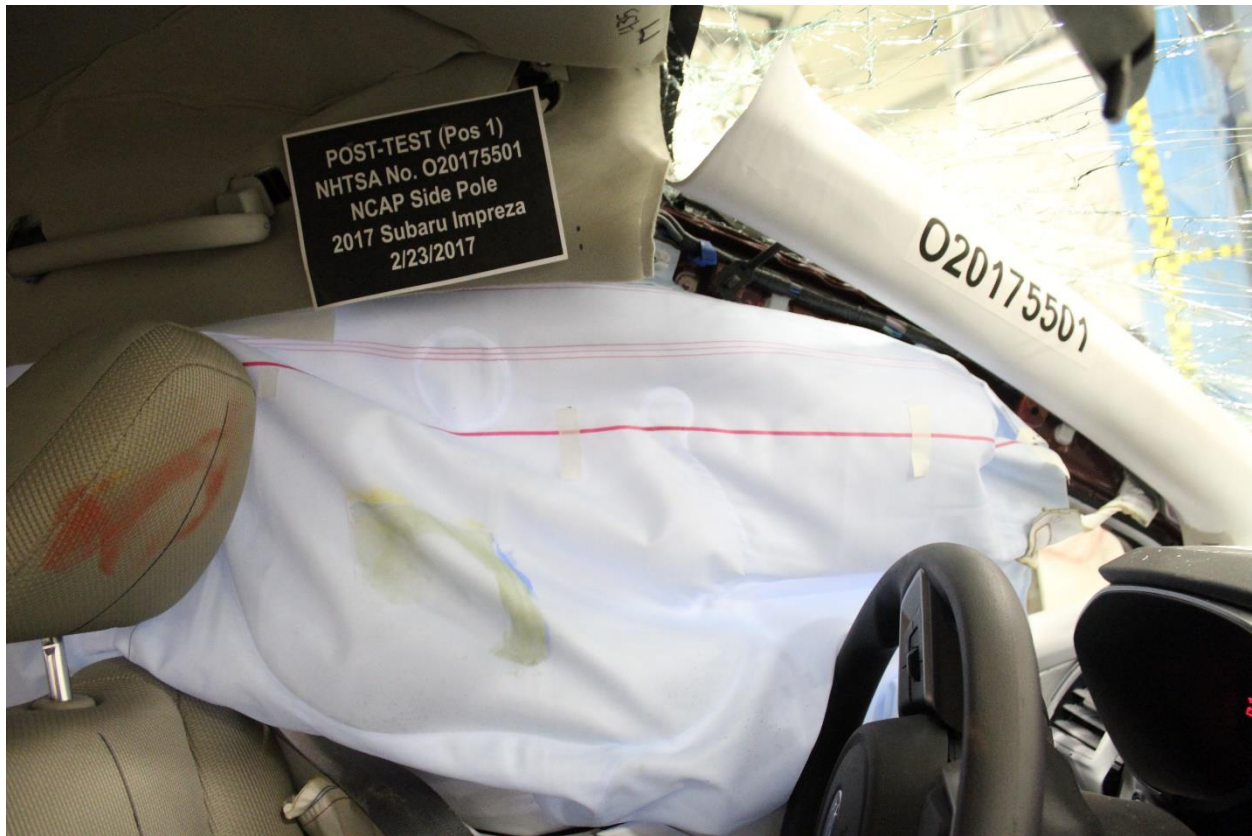
**Figure A-46: Post-Test Dummy Close-Up Head Contact with Vehicle Interior View**

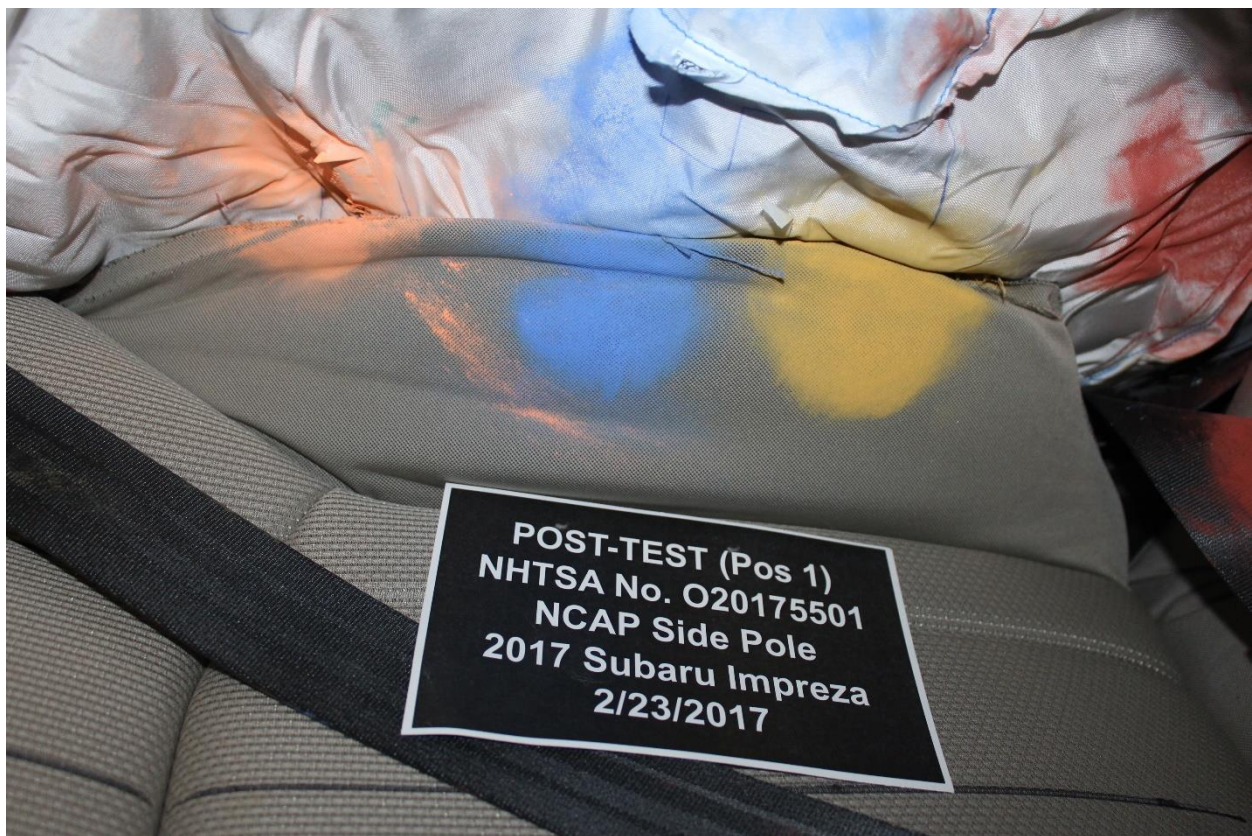
**Figure A-47: Post-Test Dummy Close-Up Head Contact with Side Airbag View**

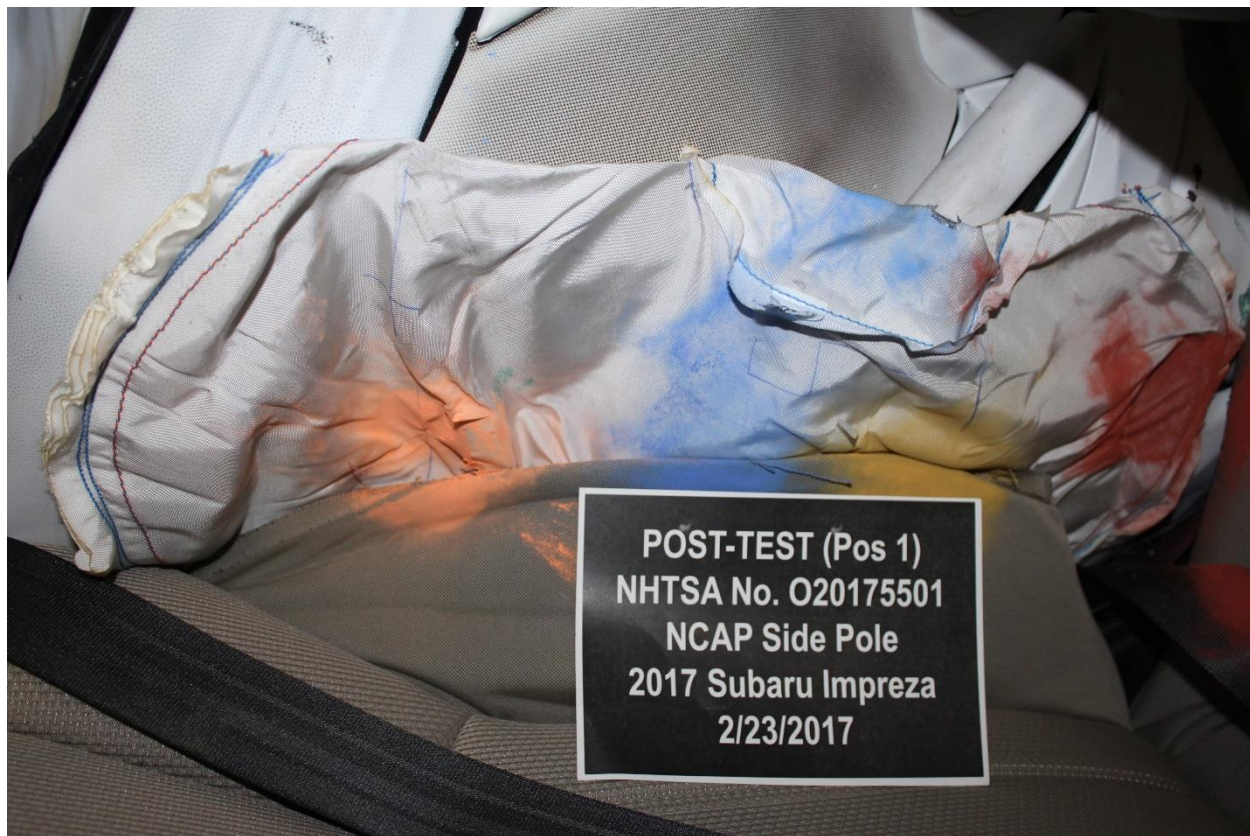
**Figure A-48: Post-Test Dummy Close-Up Torso Contact with Vehicle Interior View**

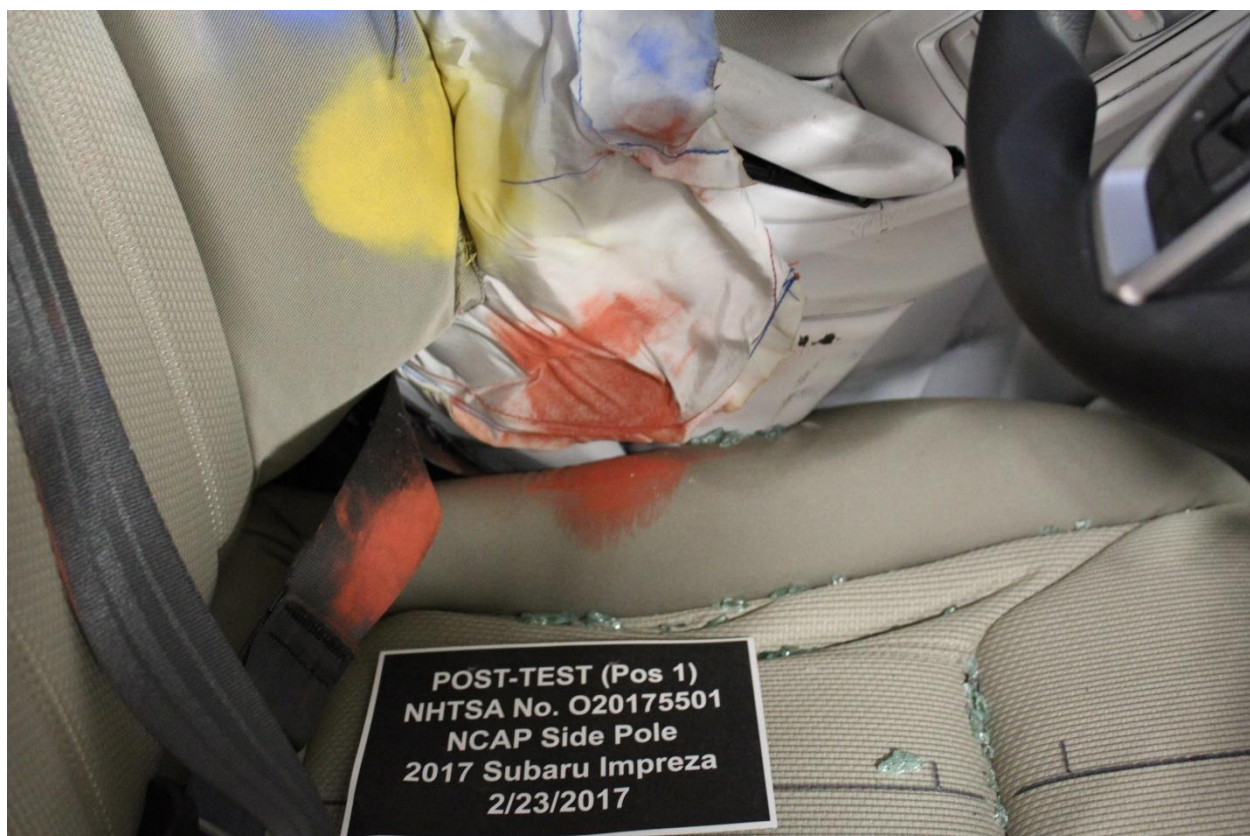
**Figure A-49: Post-Test Dummy Close-Up Torso Contact with Side Airbag View**

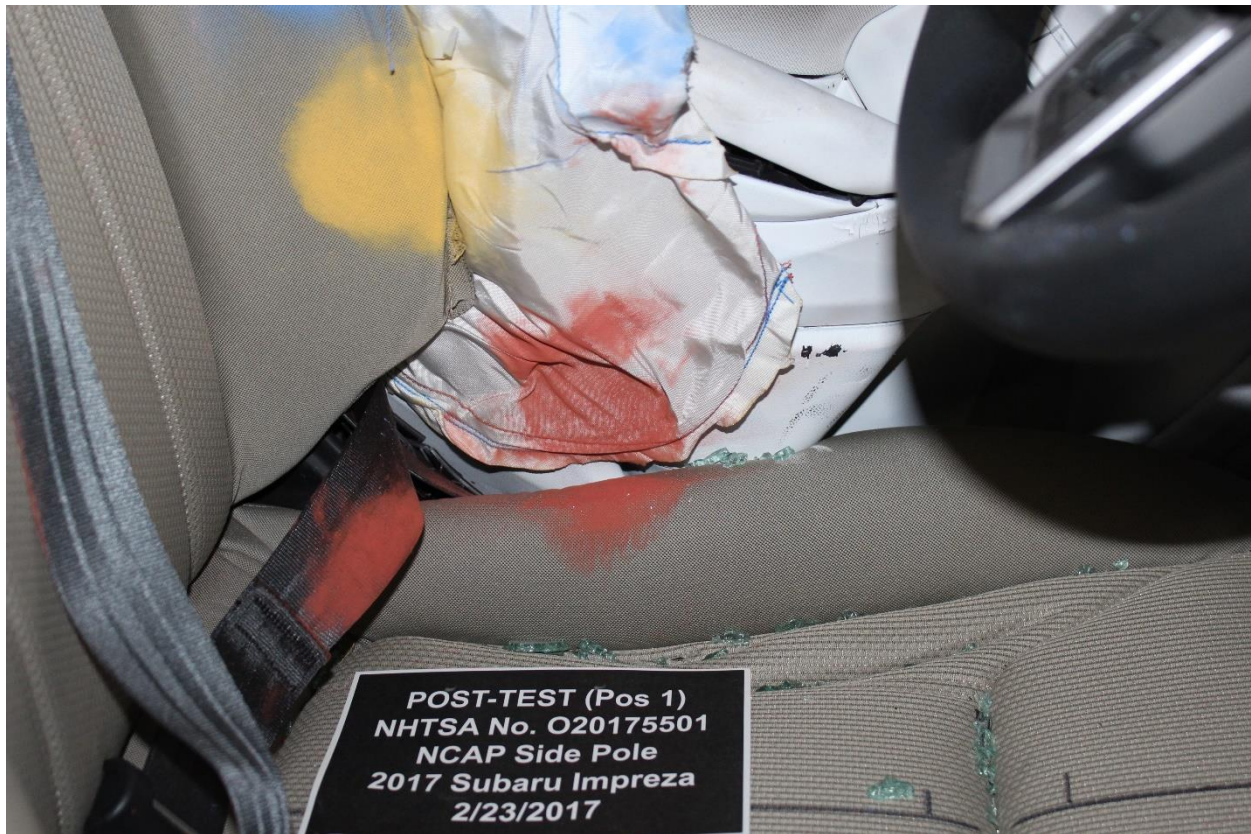
**Figure A-50: Post-Test Dummy Close-Up Pelvis Contact with Vehicle Interior View**

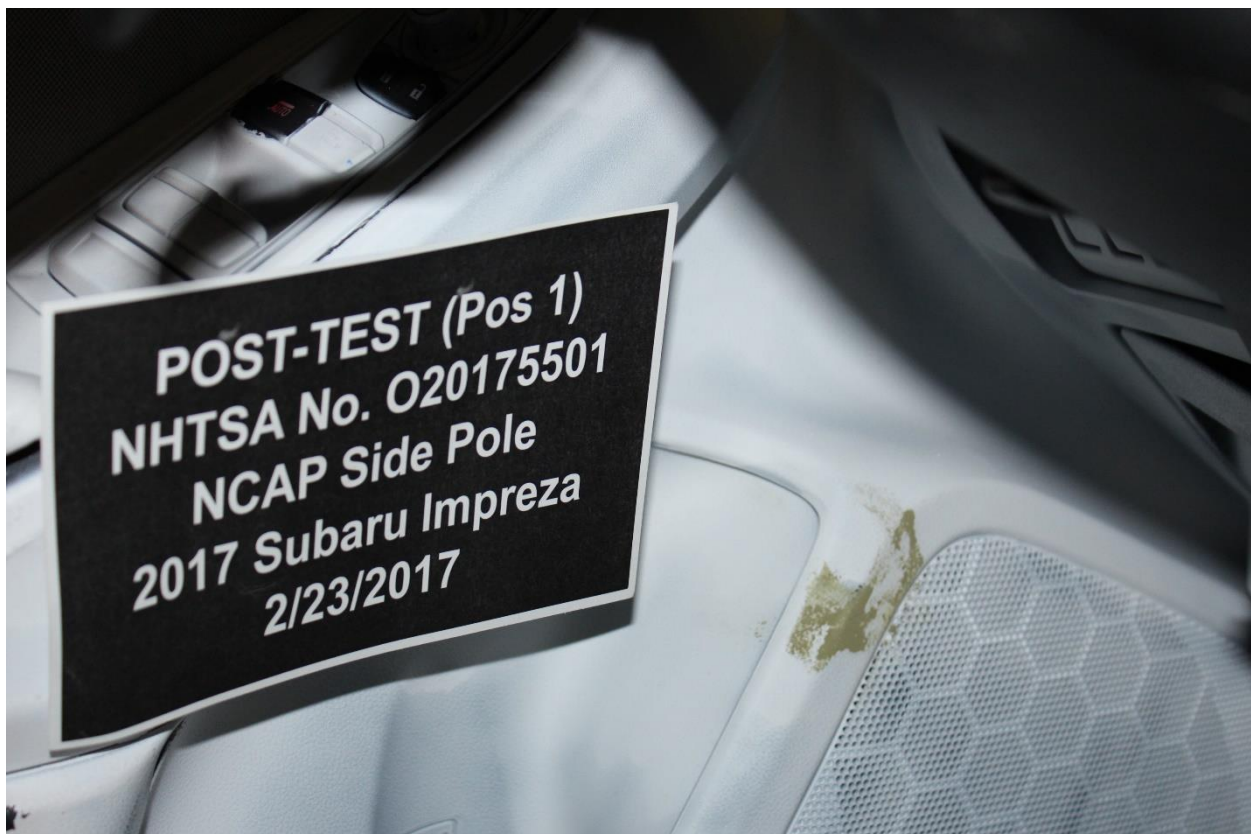
**Figure A-51: Post-Test Dummy Close-Up Pelvis Contact with Side Airbag View**

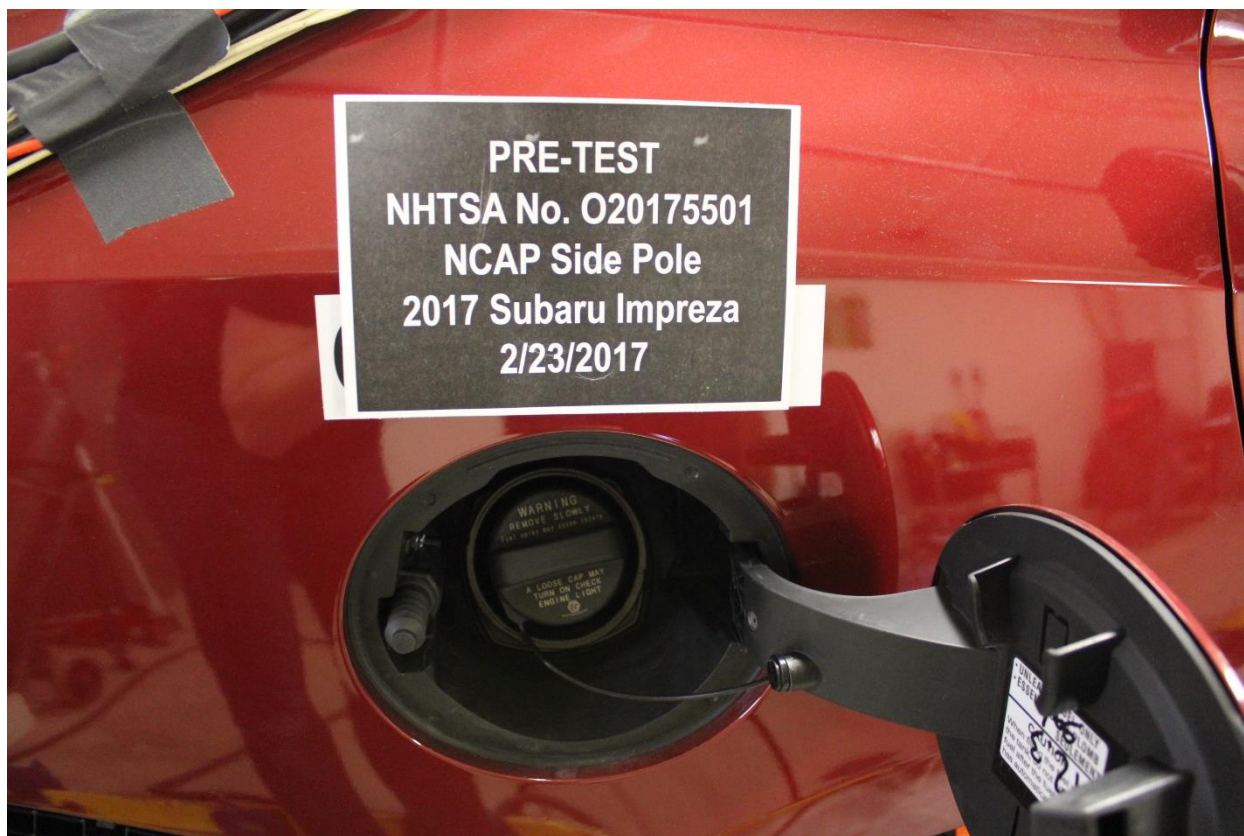
**Figure A-52: Post-Test Dummy Close-Up Knee Contact with Vehicle Interior View**

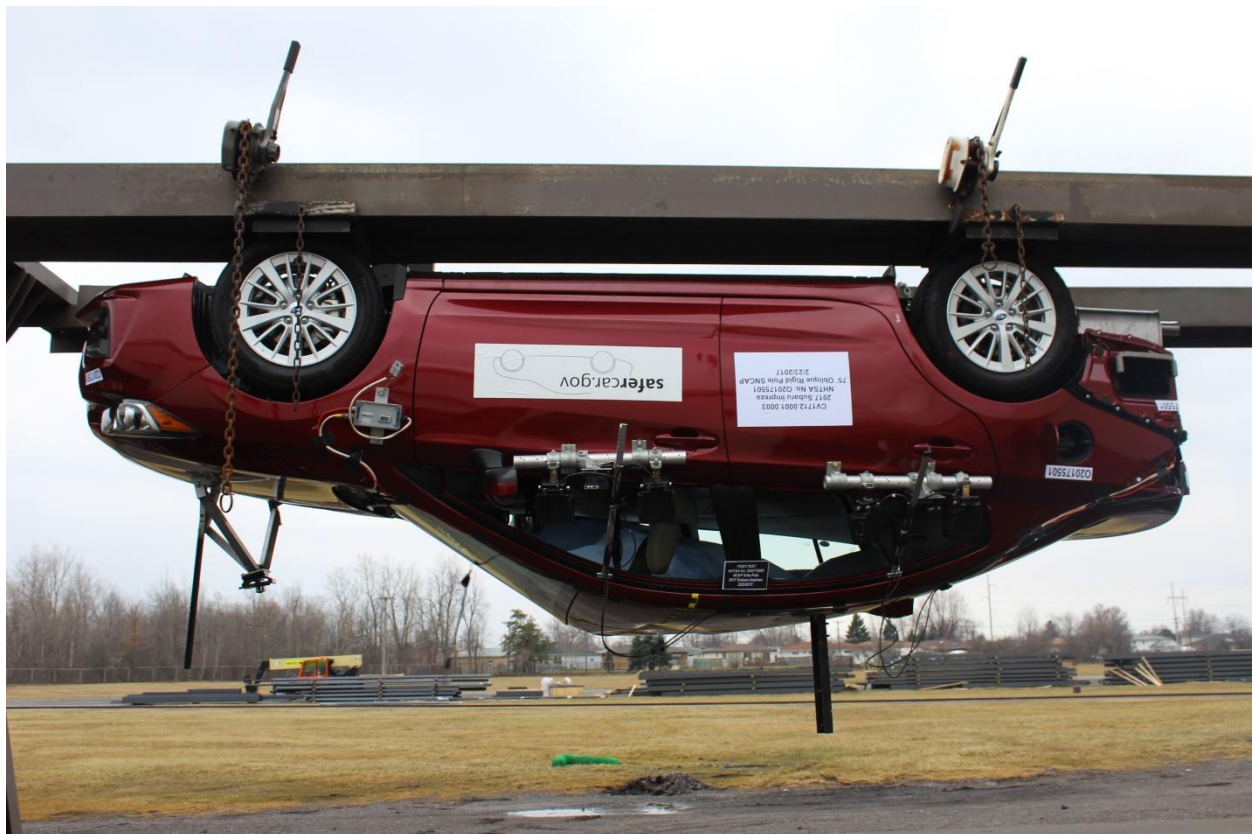
**Figure A-64: FMVSS No. 301 Static Rollover 90 Degrees**

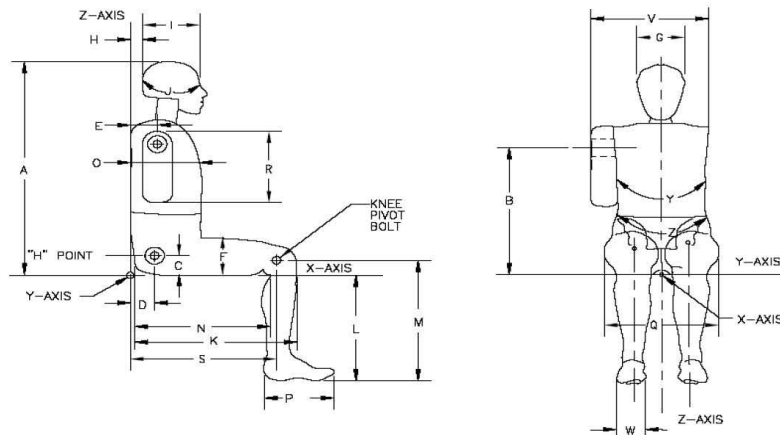
Symbol	Description	Specification (mm)		Result (mm)	Pass/Fail
A	Sitting Height	772	788	778	Pass
B	Shoulder Pivot Height	437	453	446	Pass
C	H-point Height	79	89	86	Pass
D	H-point from seatback	141	151	145	Pass
E	Shoulder Pivot from Backline	97	107	104	Pass
F	Thigh Clearance	119	135	123	Pass
G	Head Breadth	140	148	141	Pass
H	Head Back from Backline	40	46	43	Pass
I	Head Depth	178	188	183	Pass
J	Head Circumference	541	551	547	Pass
K	Buttock to Knee Length	514	540	535	Pass
L	Popliteal Height	343	369	357	Pass
M	Knee Pivot to floor height	392	409	402	Pass
N	Buttock Popliteal Length	416	442	436	Pass
O	Chest Depth w/o jacket	195	211	207	Pass
P	Foot Length	216	232	221	Pass
Q	Hip Breadth (w/pelvic plugs)	313	323	318	Pass
R	Arm Length	249	259	251	Pass
S	Knee Joint to seatback	477	493	486	Pass
V	Shoulder Width	341	357	350	Pass
W	Foot Width	78	94	84	Pass
Y	Chest Circumference w/jacket	851	881	871	Pass
Z	Waist Circumference	761	791	770	Pass

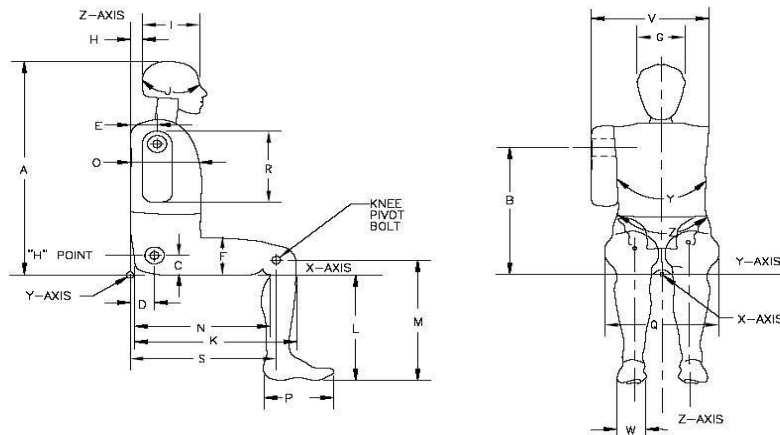
Symbol	Description	Specification (mm)		Result (mm)	Pass/Fail
A	Sitting Height	772	788	778	Pass
B	Shoulder Pivot Height	437	453	447	Pass
C	H-point Height	79	89	87	Pass
D	H-point from seatback	141	151	145	Pass
E	Shoulder Pivot from Backline	97	107	105	Pass
F	Thigh Clearance	119	135	123	Pass
G	Head Breadth	140	148	142	Pass
H	Head Back from Backline	40	46	43	Pass
I	Head Depth	178	188	183	Pass
J	Head Circumference	541	551	547	Pass
K	Buttock to Knee Length	514	540	534	Pass
L	Popliteal Height	343	369	357	Pass
M	Knee Pivot to floor height	392	409	402	Pass
N	Buttock Popliteal Length	416	442	436	Pass
O	Chest Depth w/o jacket	195	211	206	Pass
P	Foot Length	216	232	221	Pass
Q	Hip Breadth (w/pelvic plugs)	313	323	318	Pass
R	Arm Length	249	259	251	Pass
S	Knee Joint to seatback	477	493	485	Pass
V	Shoulder Width	341	357	351	Pass
W	Foot Width	78	94	84	Pass
Y	Chest Circumference w/jacket	851	881	871	Pass
Z	Waist Circumference	761	791	770	Pass
